PERATION

GREENHOUSE

SCIENTIFIC DIRECTOR'S REPORT

ANNEX 3.2 U. S. NAVY STRUCTURES

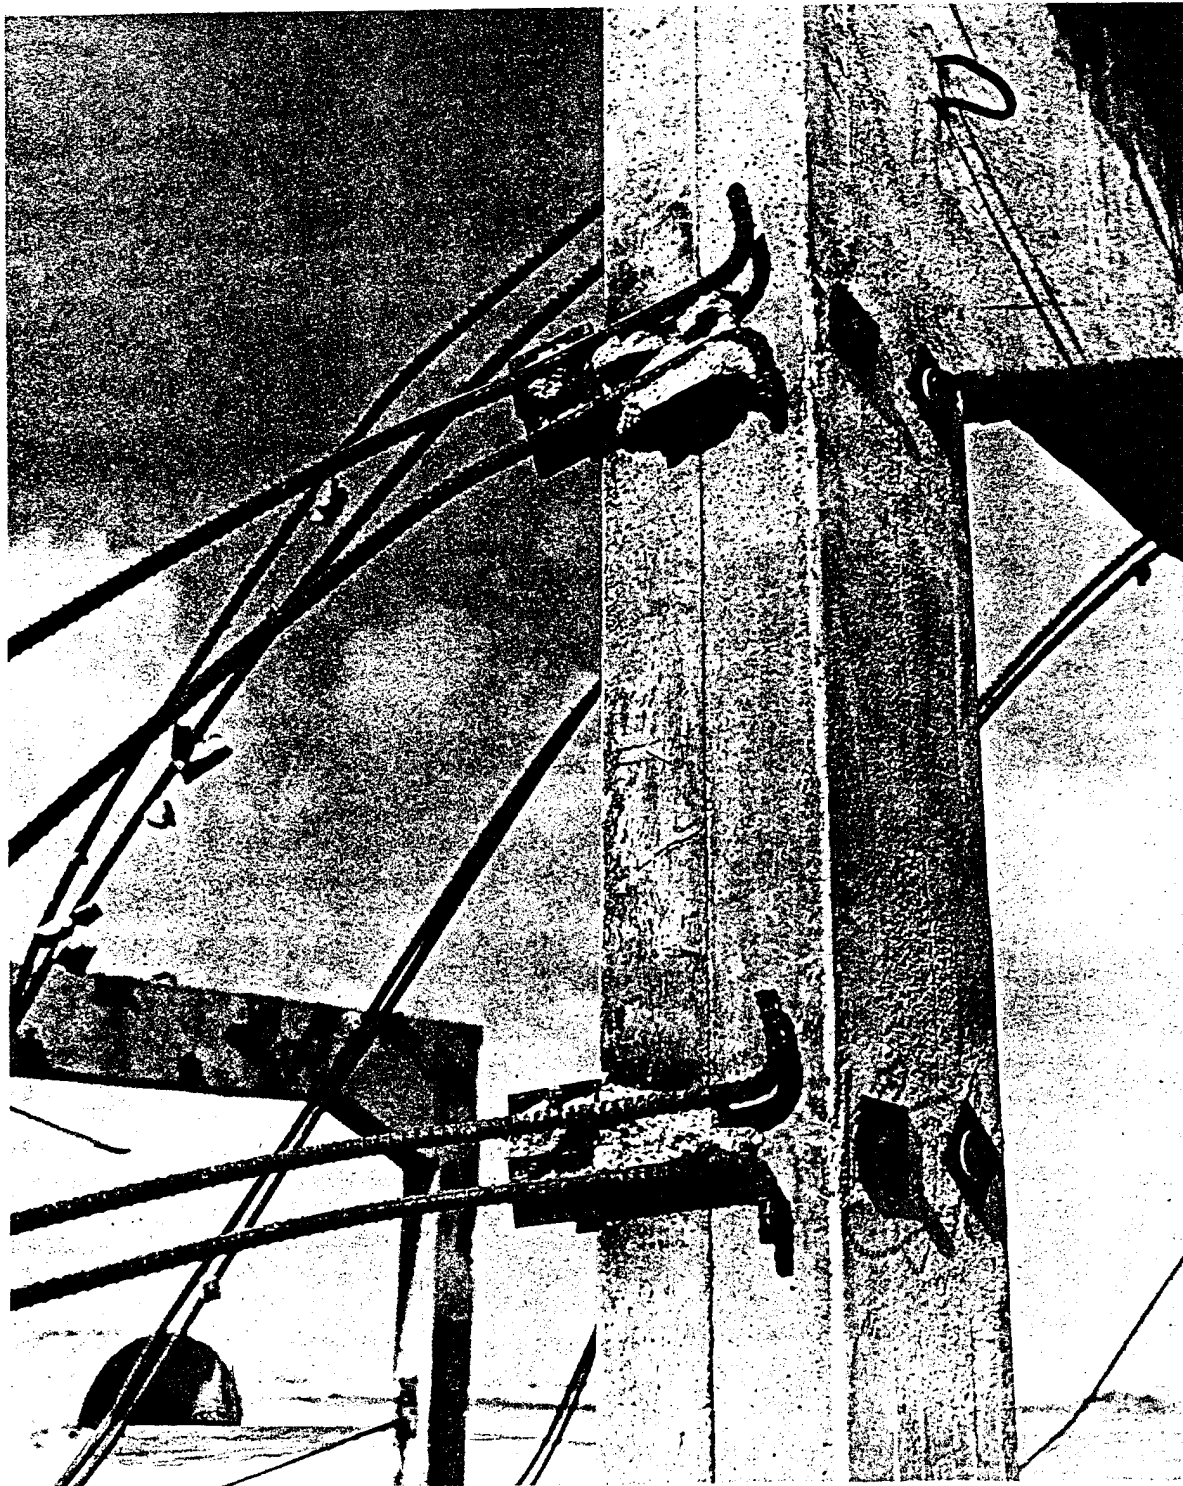
Fig. L.85 Steel from Rear Panels Which Remained When Panel Blew Back, Structure 3.2.2a

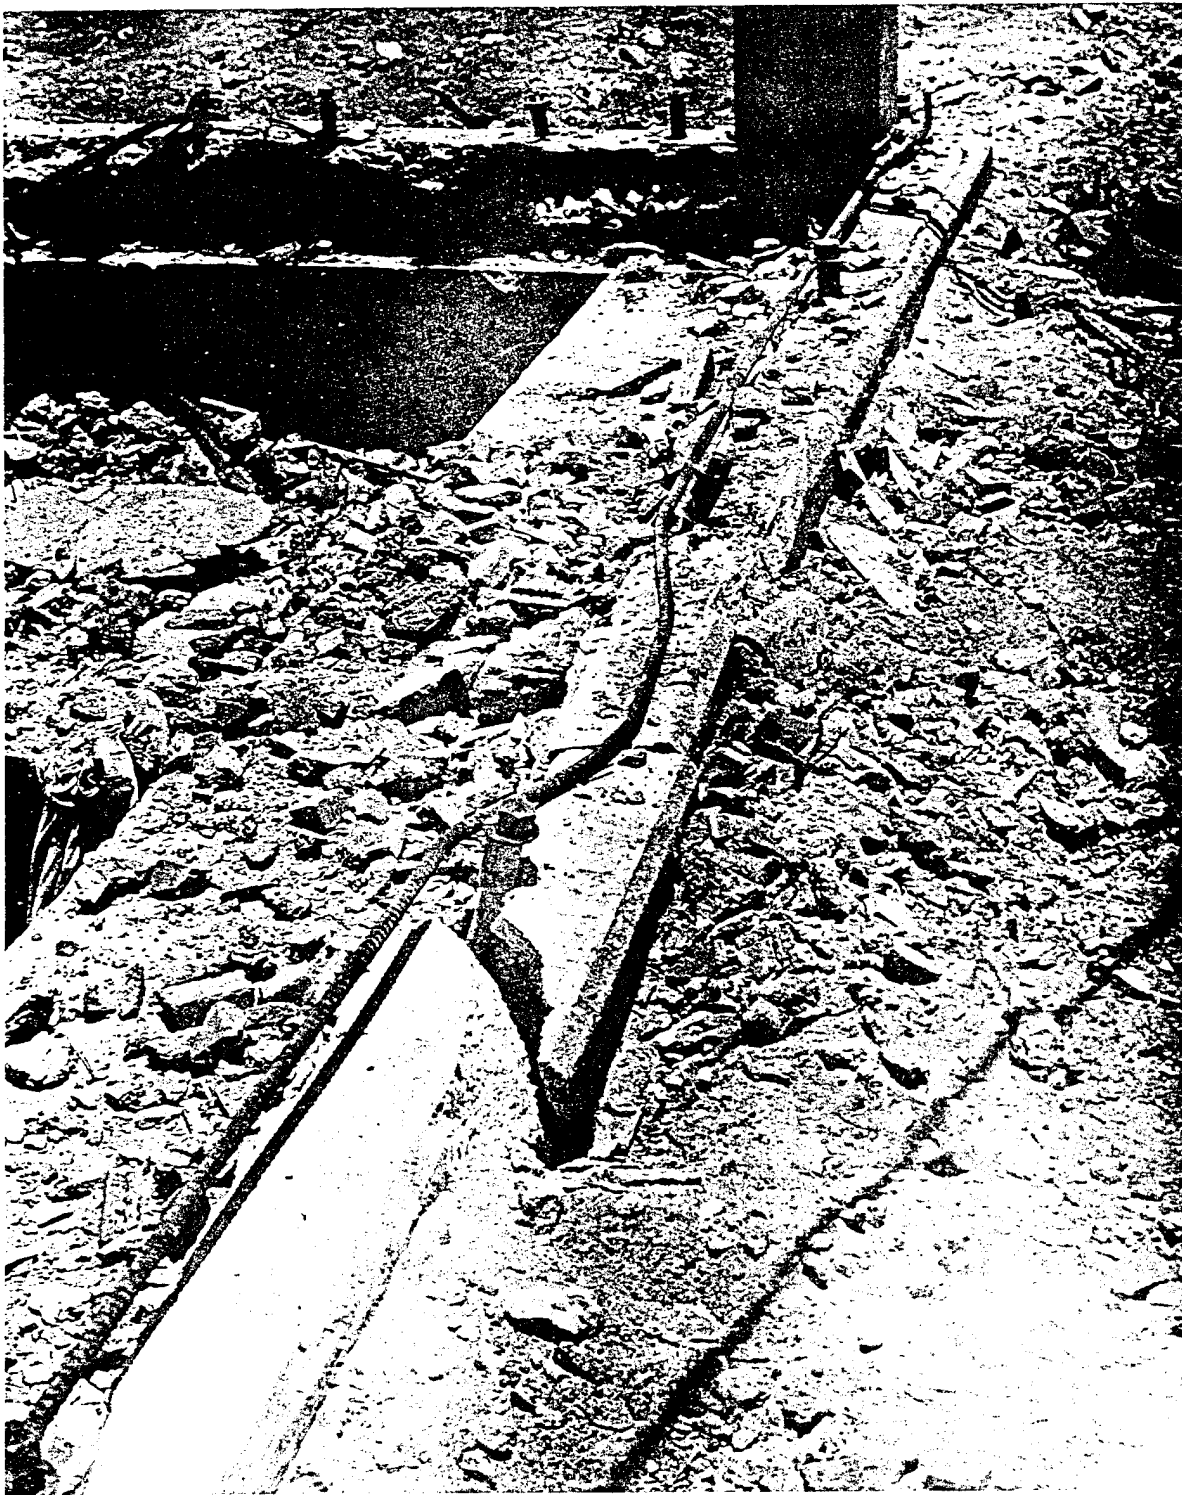
Fig. L.86 Left Rear Anchor Bolts Bent Back by Pressure from Interior, Structure 3.2.2a

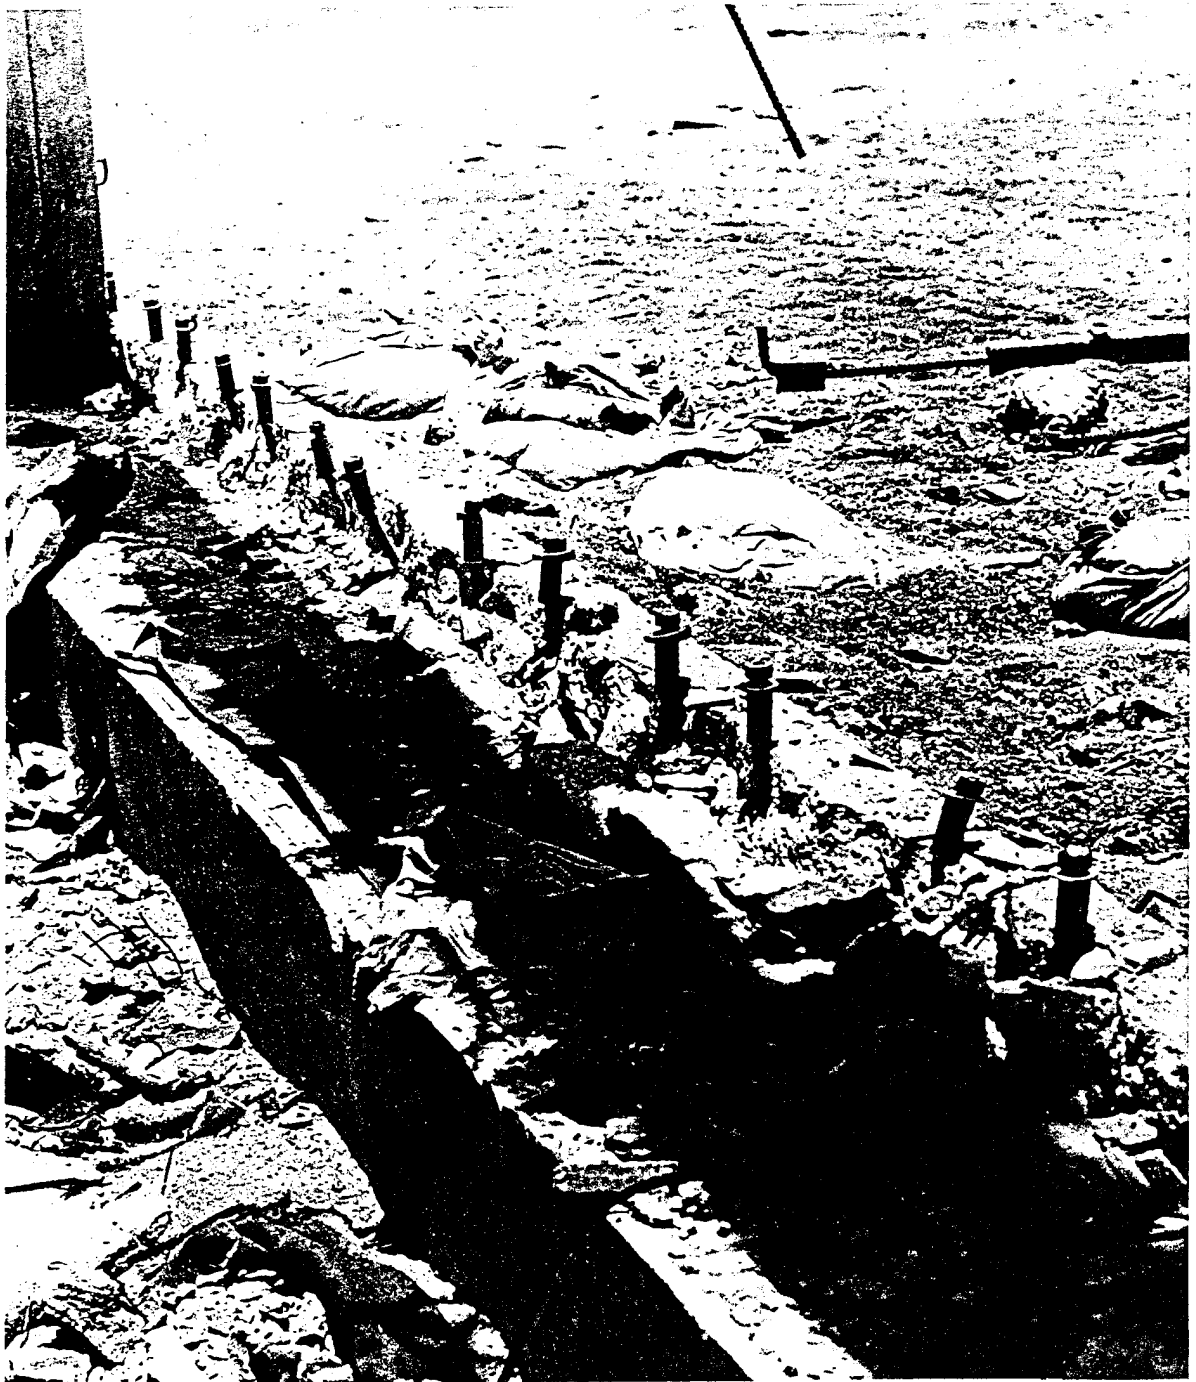
Fig. L.87 Left Side Anchor Bolts, Structure 3.2.2a. Double or "S" bend indicates exterior pressure before pressure entered building interior.

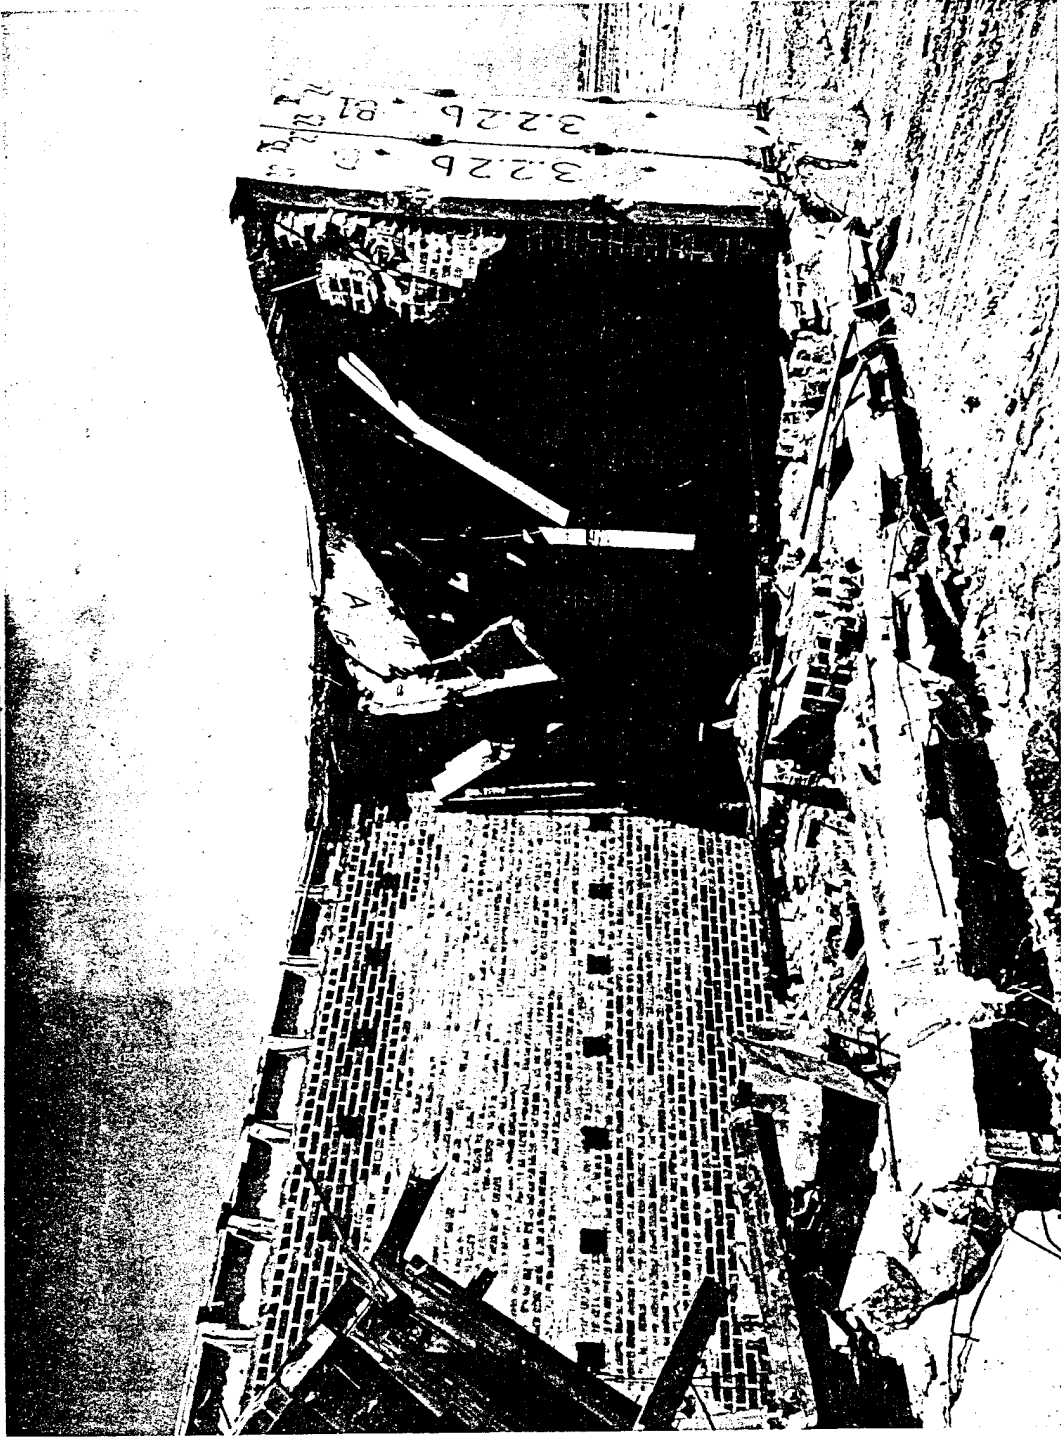
Fig. L.103 View of Right Side after Removal of Right Half of Roof and Front Wall, Structure 3.2.2b, Note crack in brick rear wall.

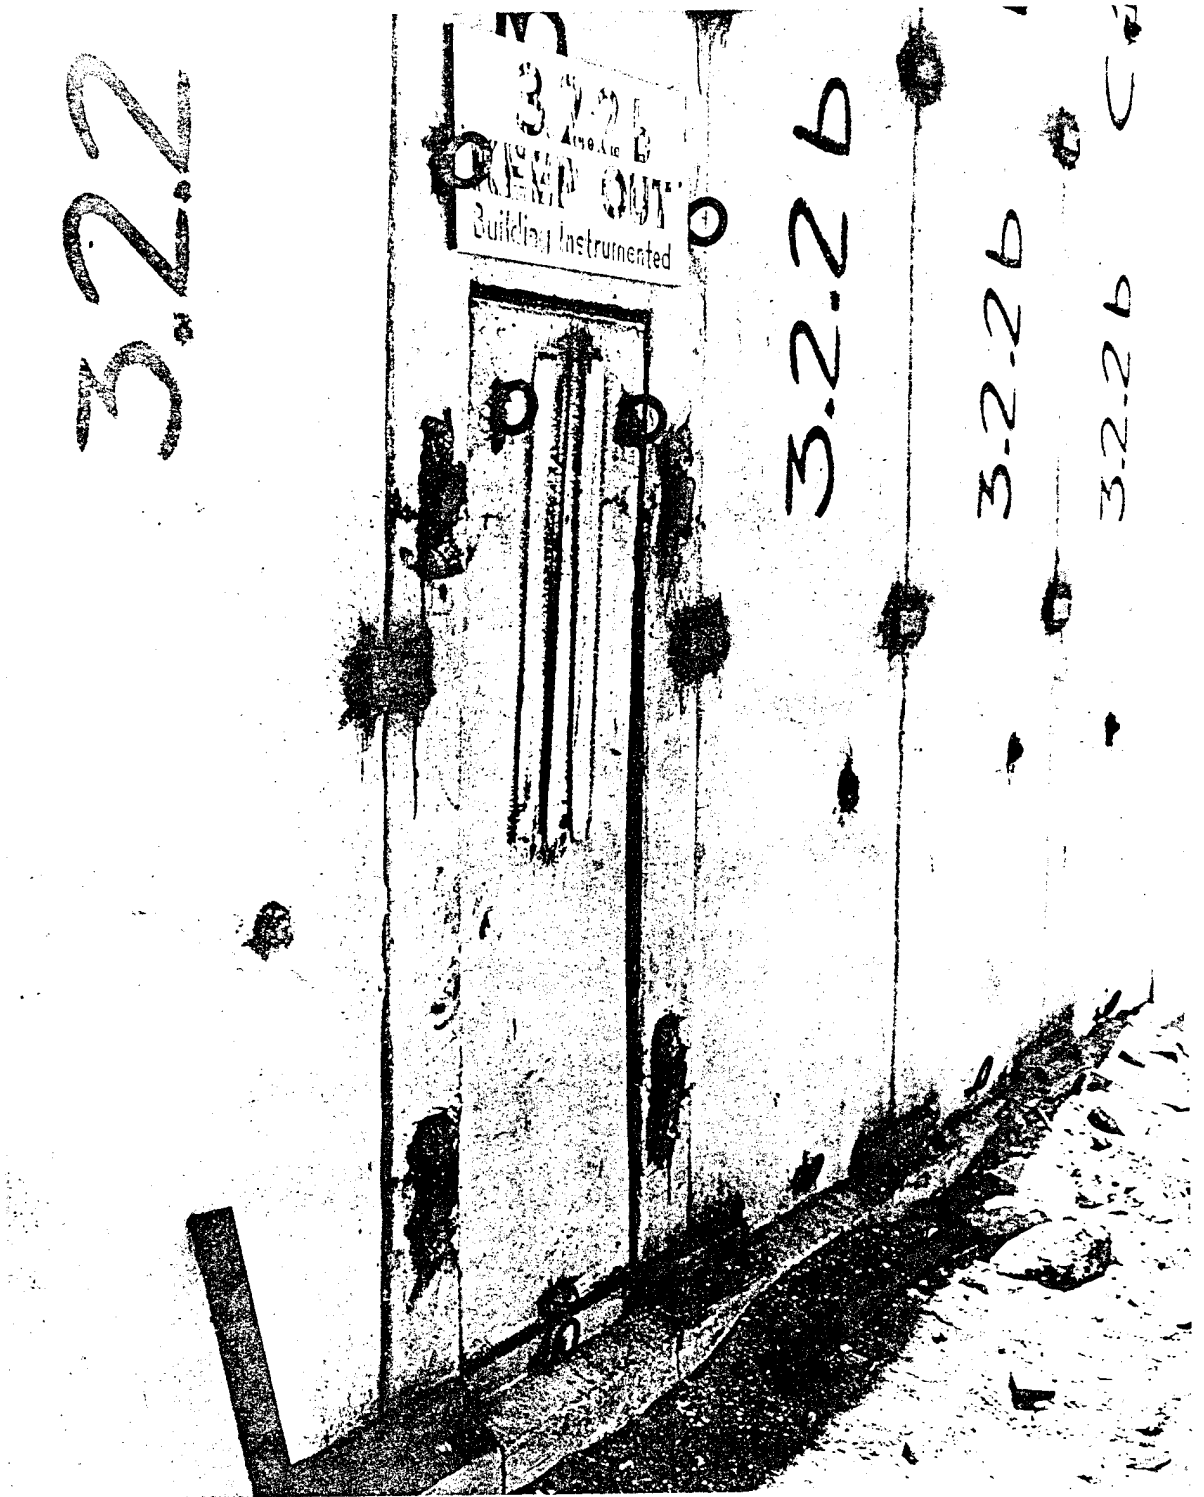
Fig. L.111 Deformed Door in Place, Structure 3.2.2b

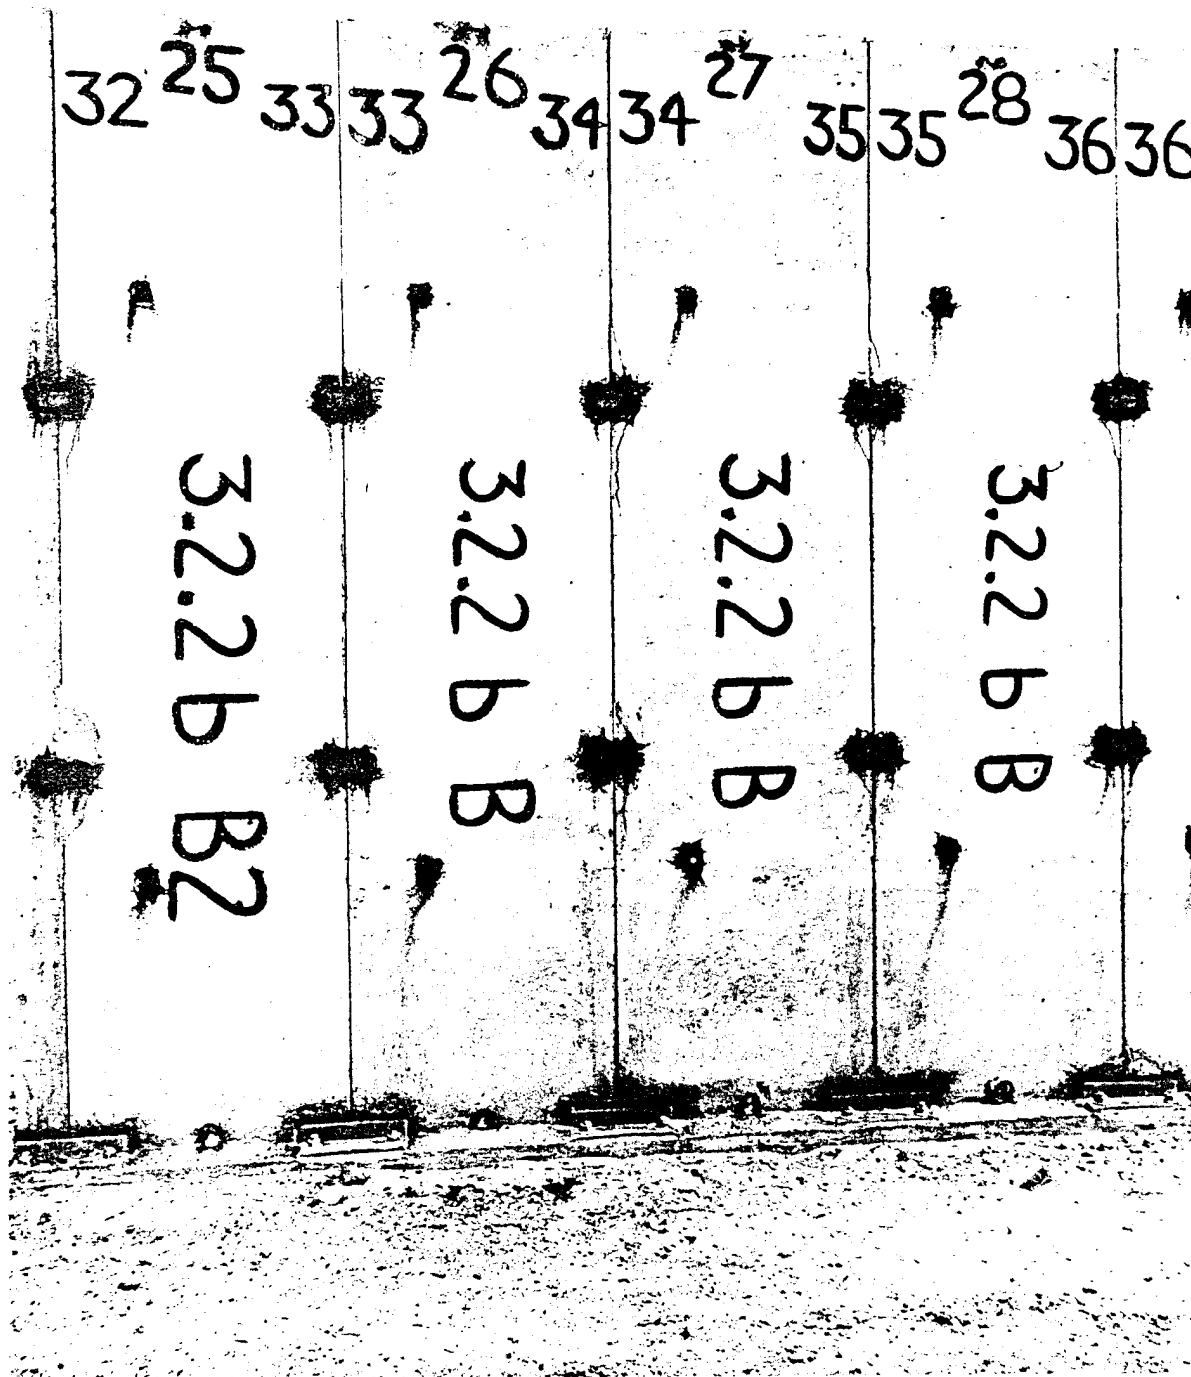
Fig. L.113 Left Corner of Rear Wall, Structure 3.2.2b. Note cracks at splice plates.

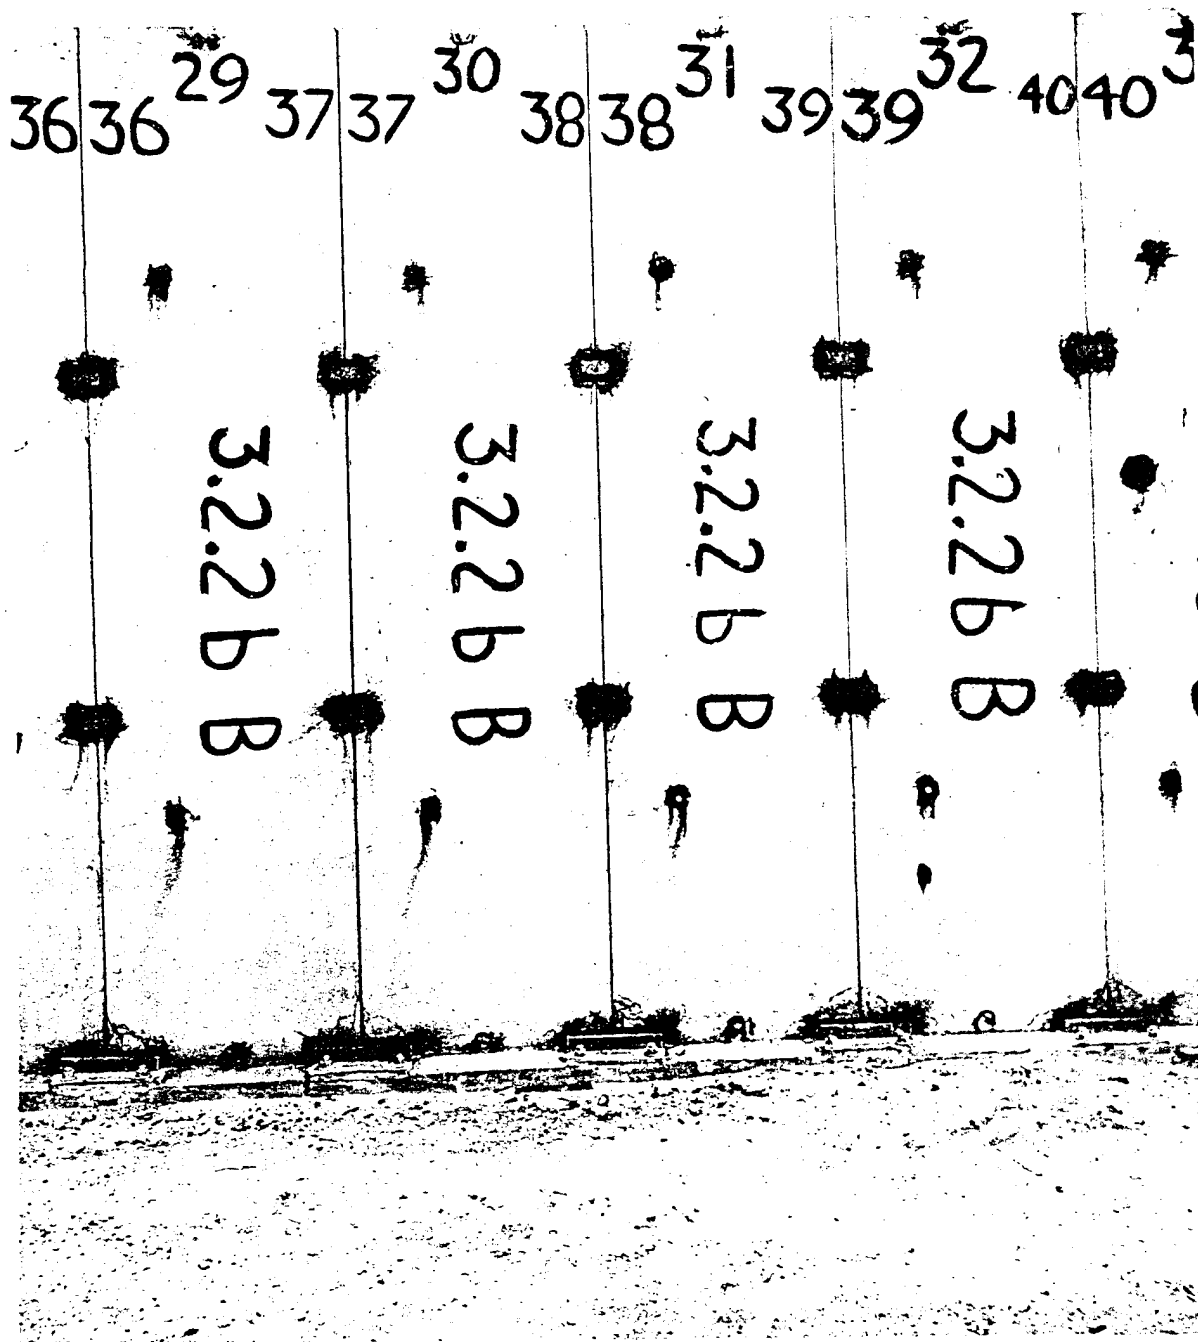
Fig. L.114 Rear-wall Panels at Left Center. Structure 3.2.2b. Note scabbing at base.

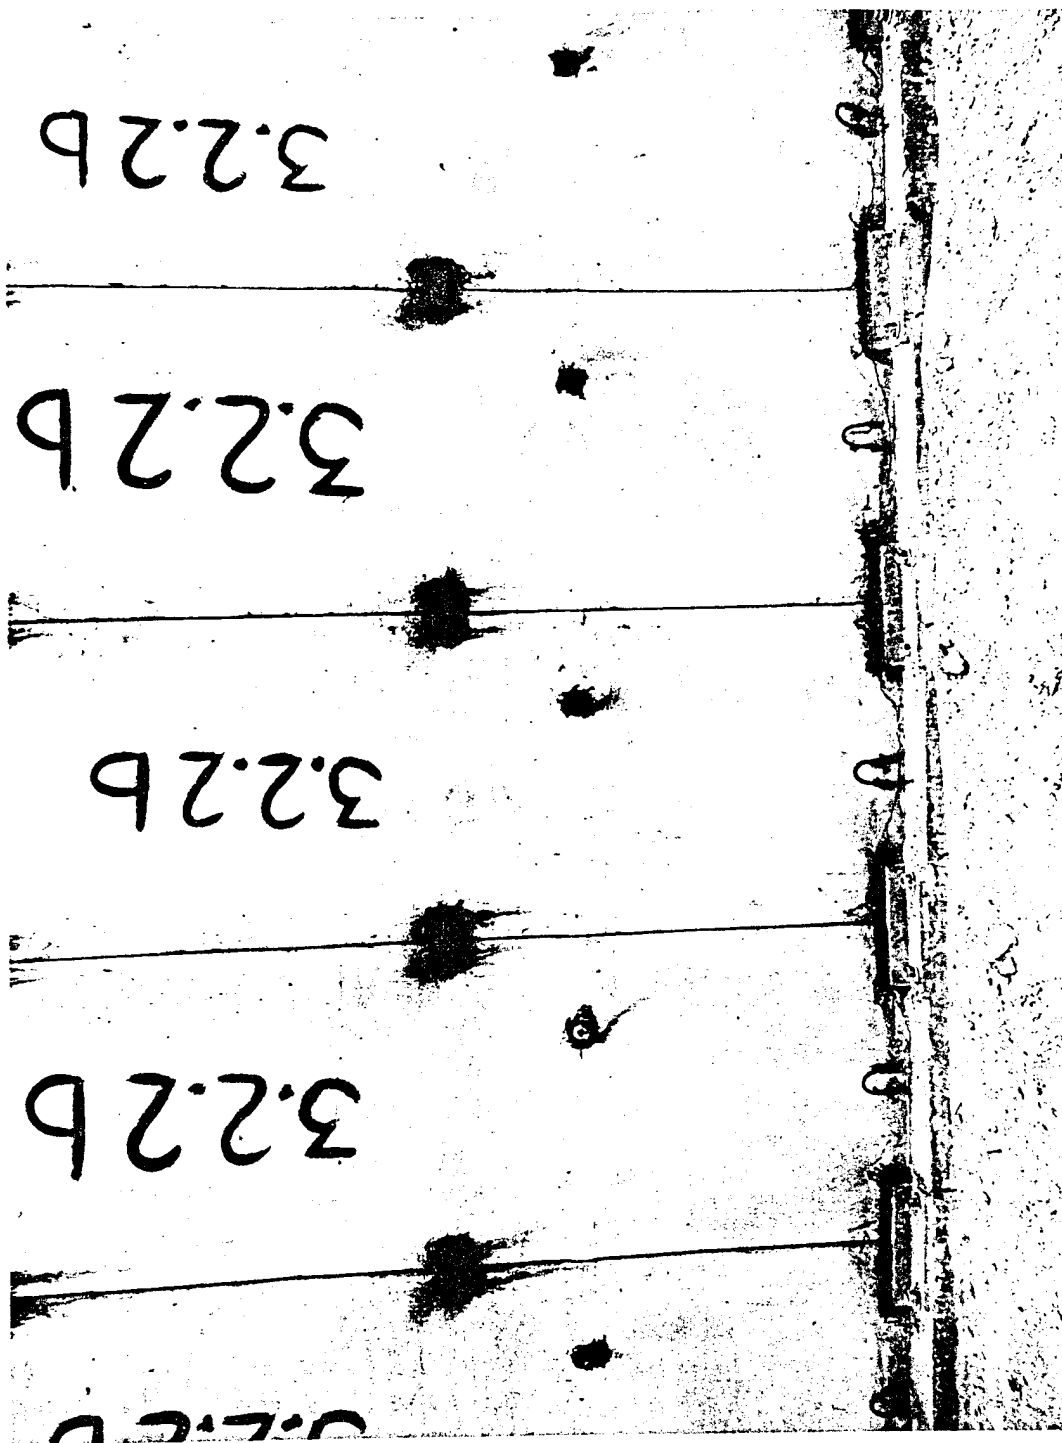
Fig. L.117 Left Side Wall near Front Showing Cracks and Scabbing near Angles, Structure 3.2.2b

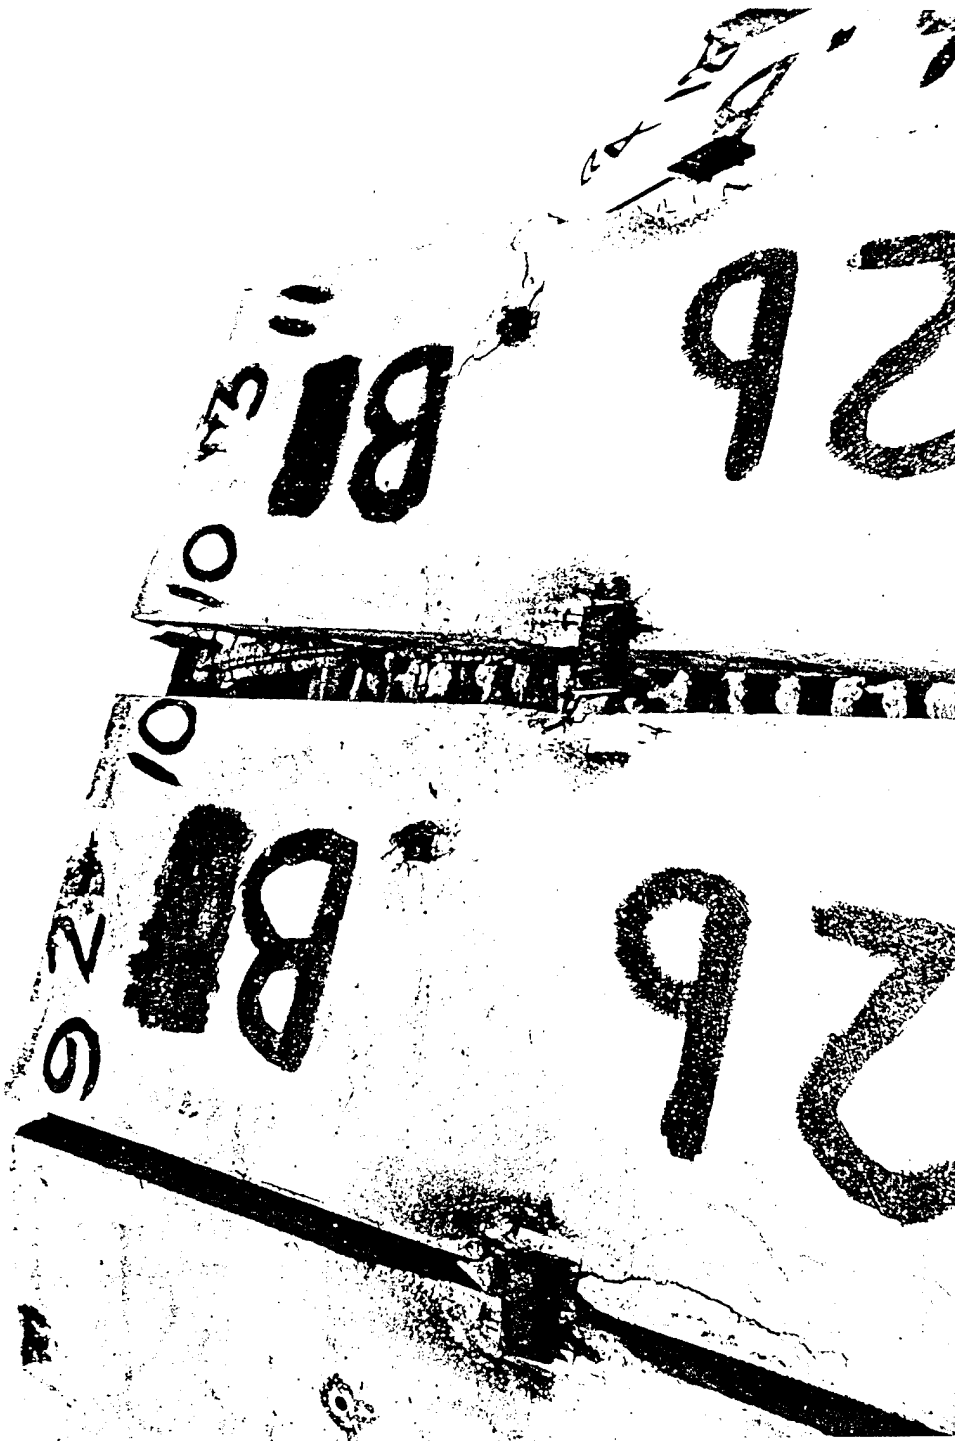
Fig. L.118 Failure at Splice Plate by Shearing of Reinforcing Bar, Structure 3.2.2b. Note tension steel at top of panel pulled out by connection to roof panel. View at left front fold.

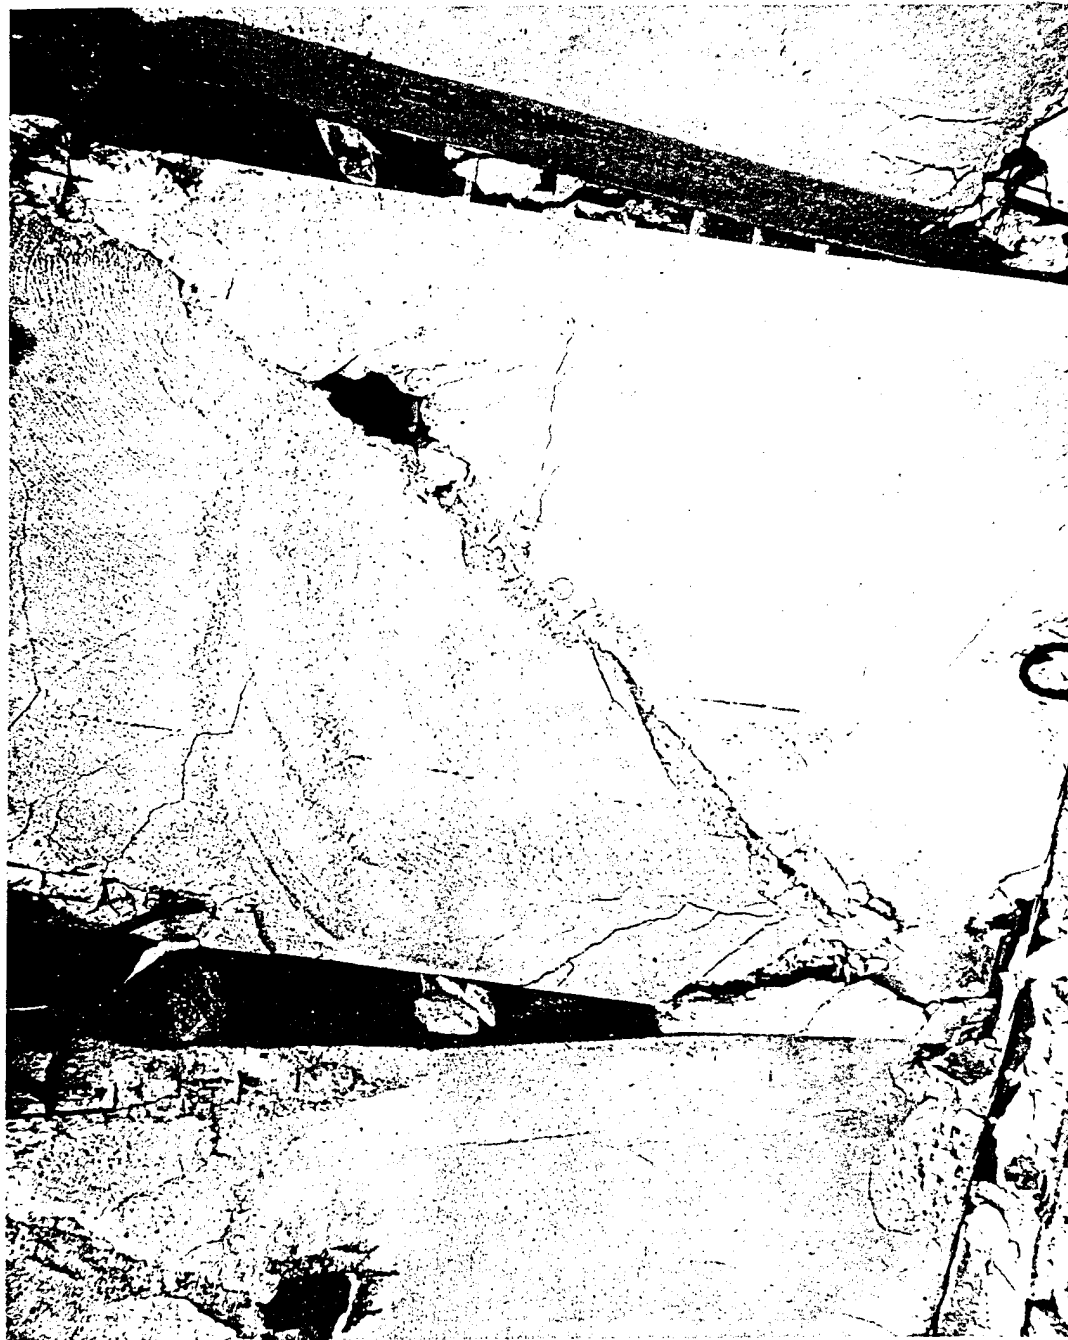
Fig. L.119 Puncturing of Front Panel by Brick Anchor Bolts Pulling Out, Structure 3.2.2b

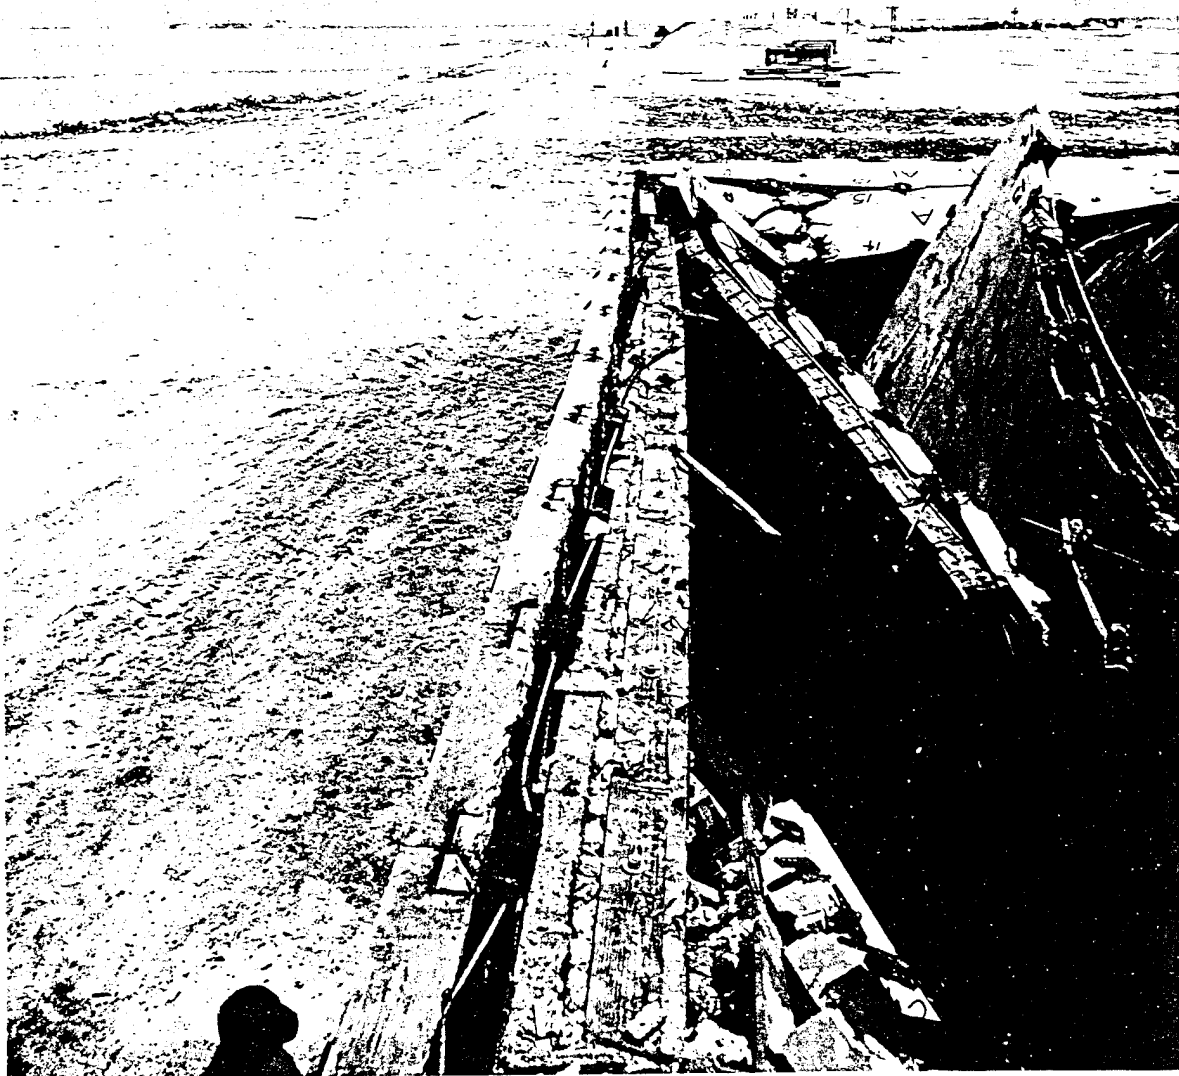
Fig. L.120 View Showing Dishing of Rear Wall and Welding Failures in Top Connections, Structure 3.2.2b

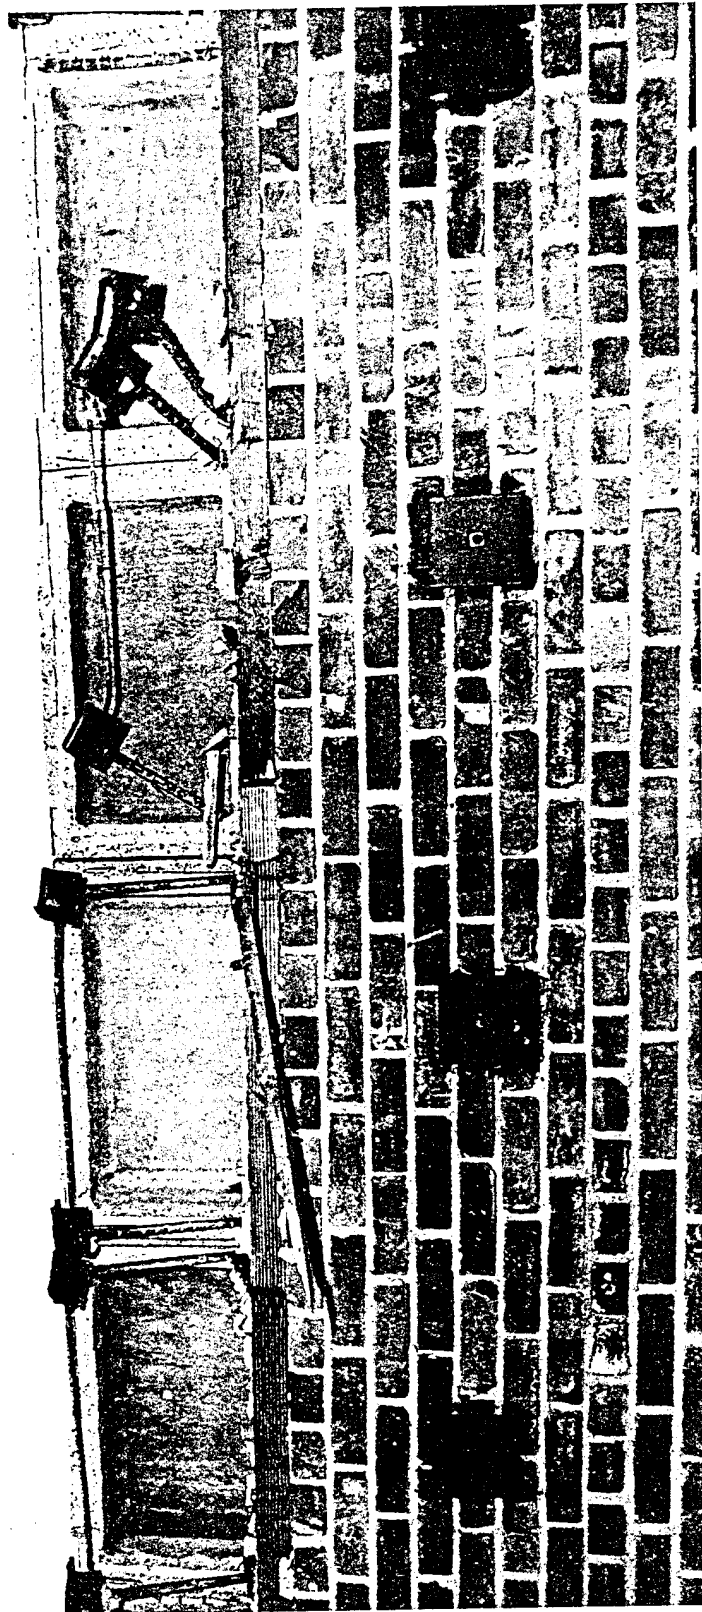
Fig. L.121 Close-up of Connection Failures atop Rear Wall, Structure 3.2.2b

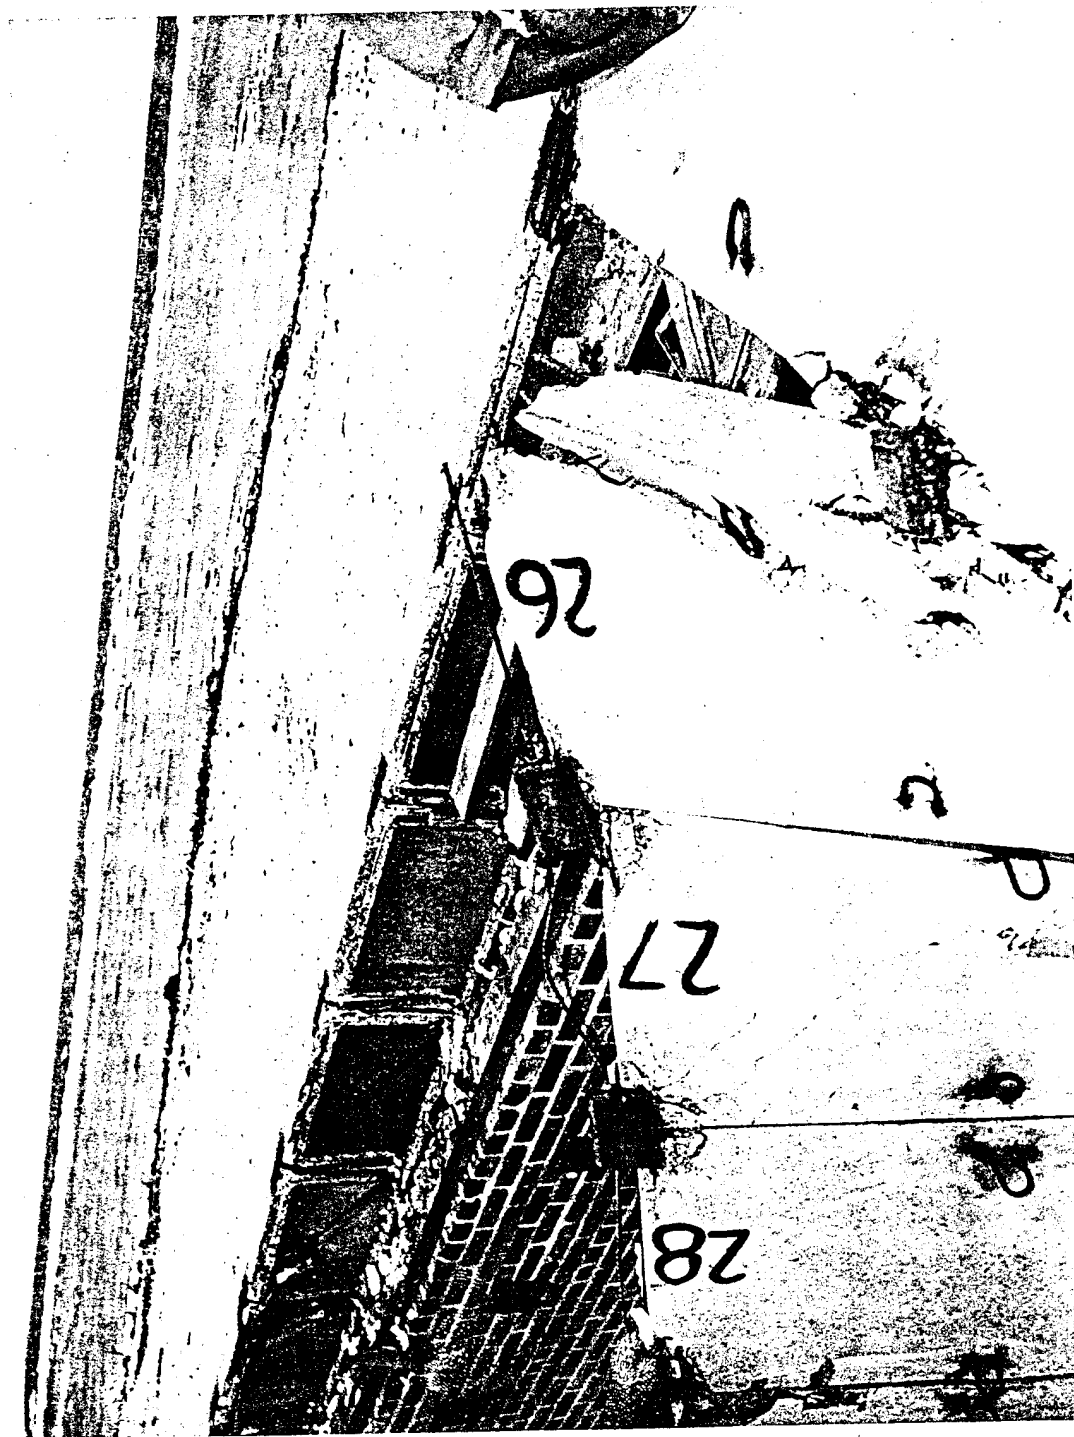
Fig. L.123 Right Rear Corner, Structure 3.2.2b. Note separation of angles from tension bars in rear-wall panels.

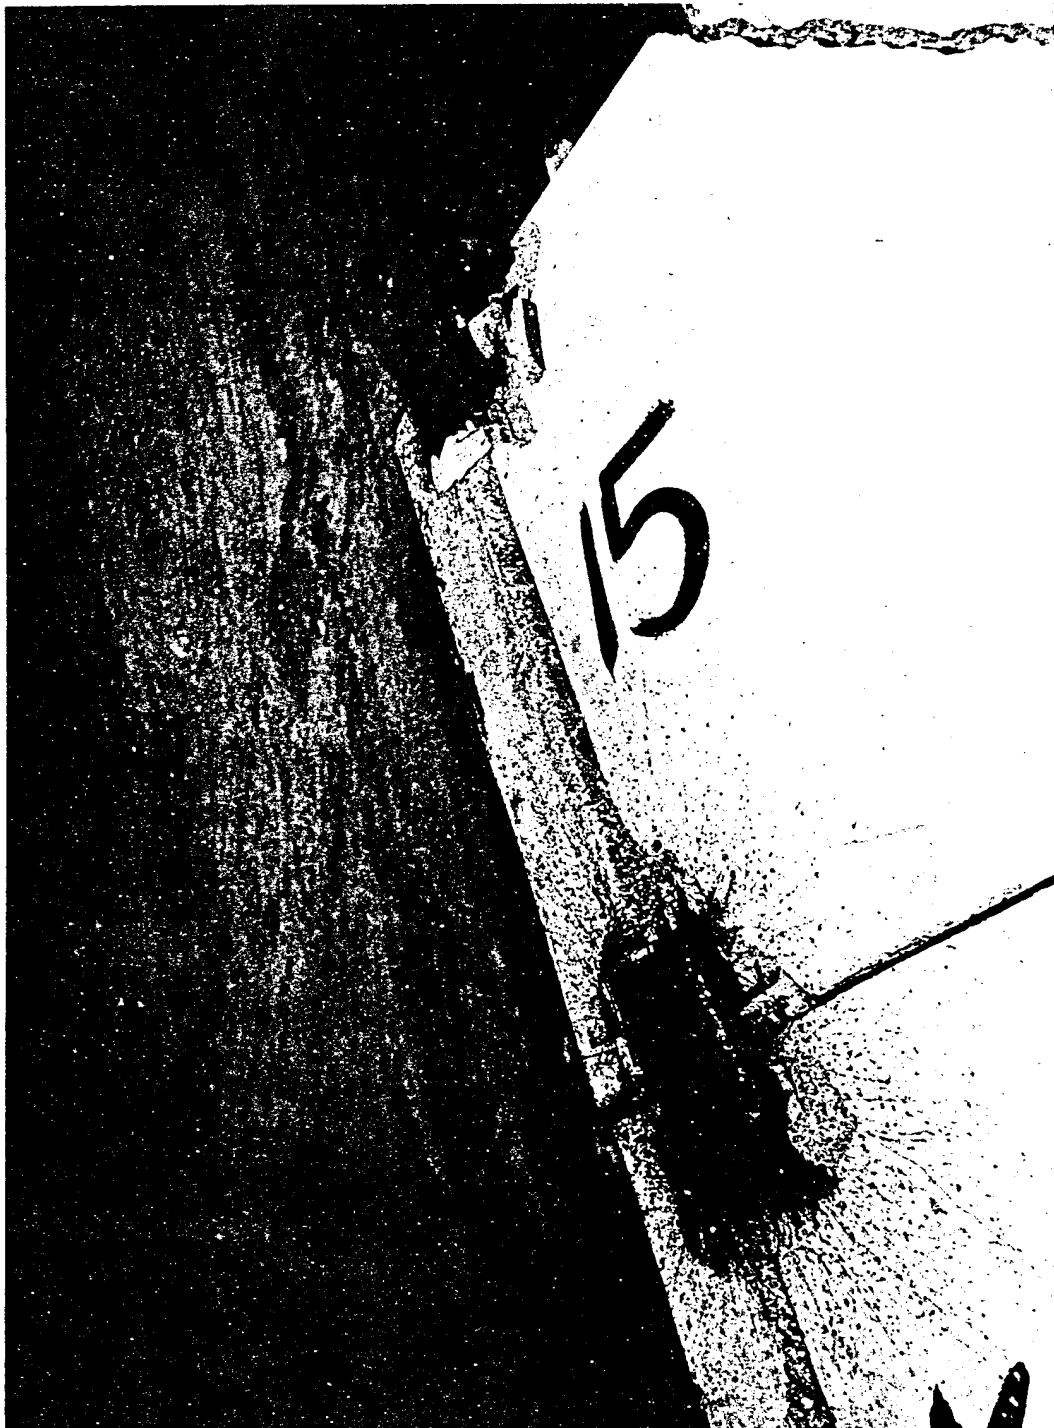
Fig. L.126 Atop Right Front Corner at Point of Roof Break Showing Stress at Splice Plate, Structure 3.2.2b

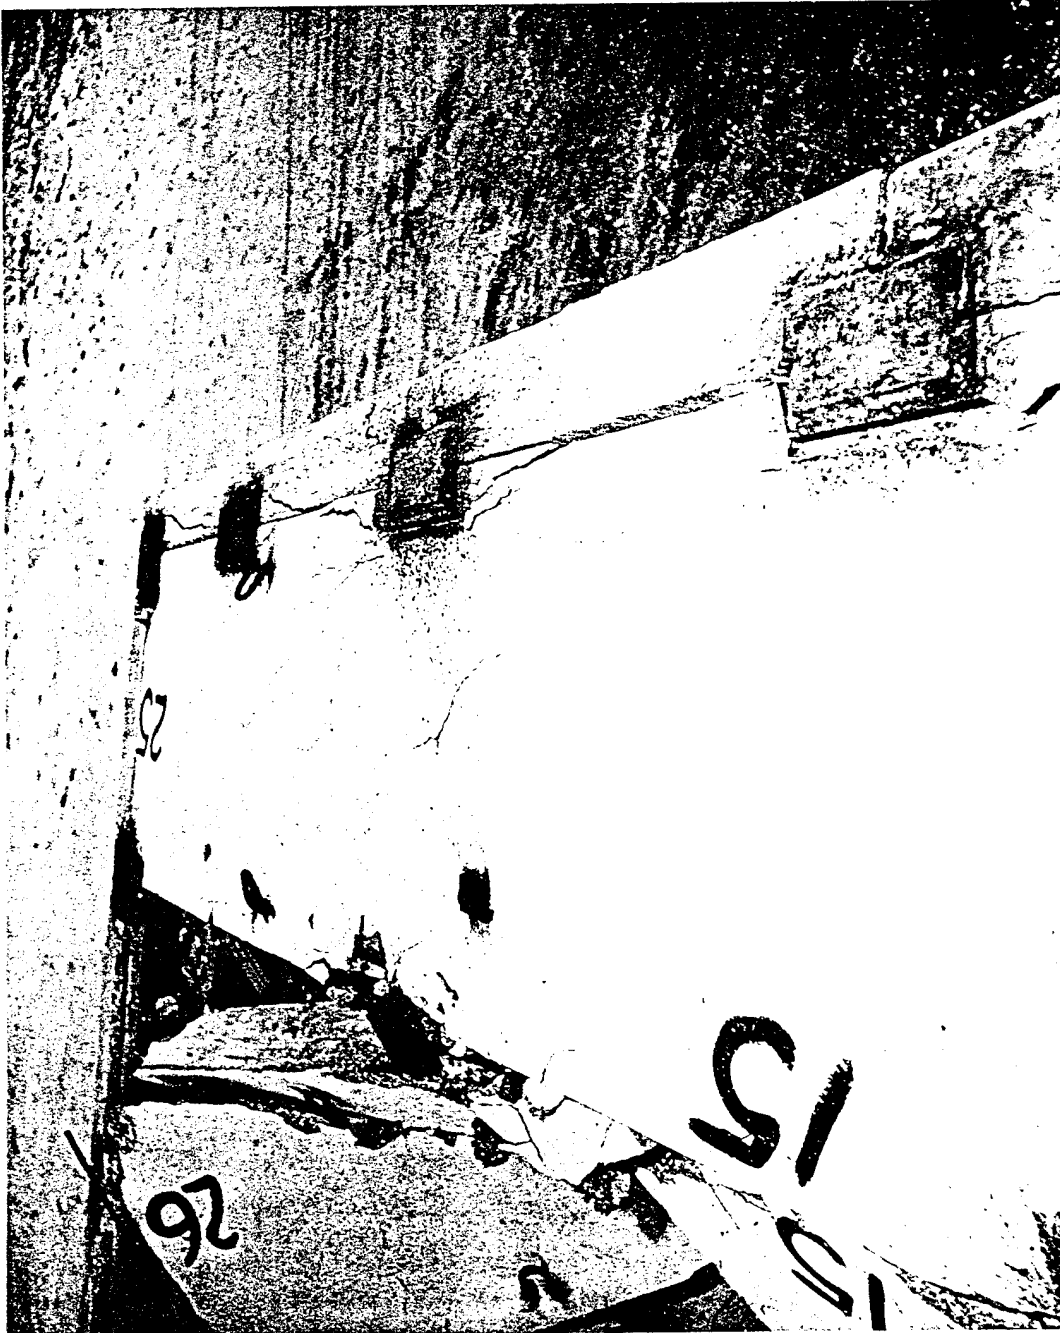
Fig. L.128 Rear Half of Roof on Right Side, Structure 3.2.2b
